Deer on Roads Seminar

Suffolk B1106 Rumble Strip Project

DEER SAFETY PROJECT

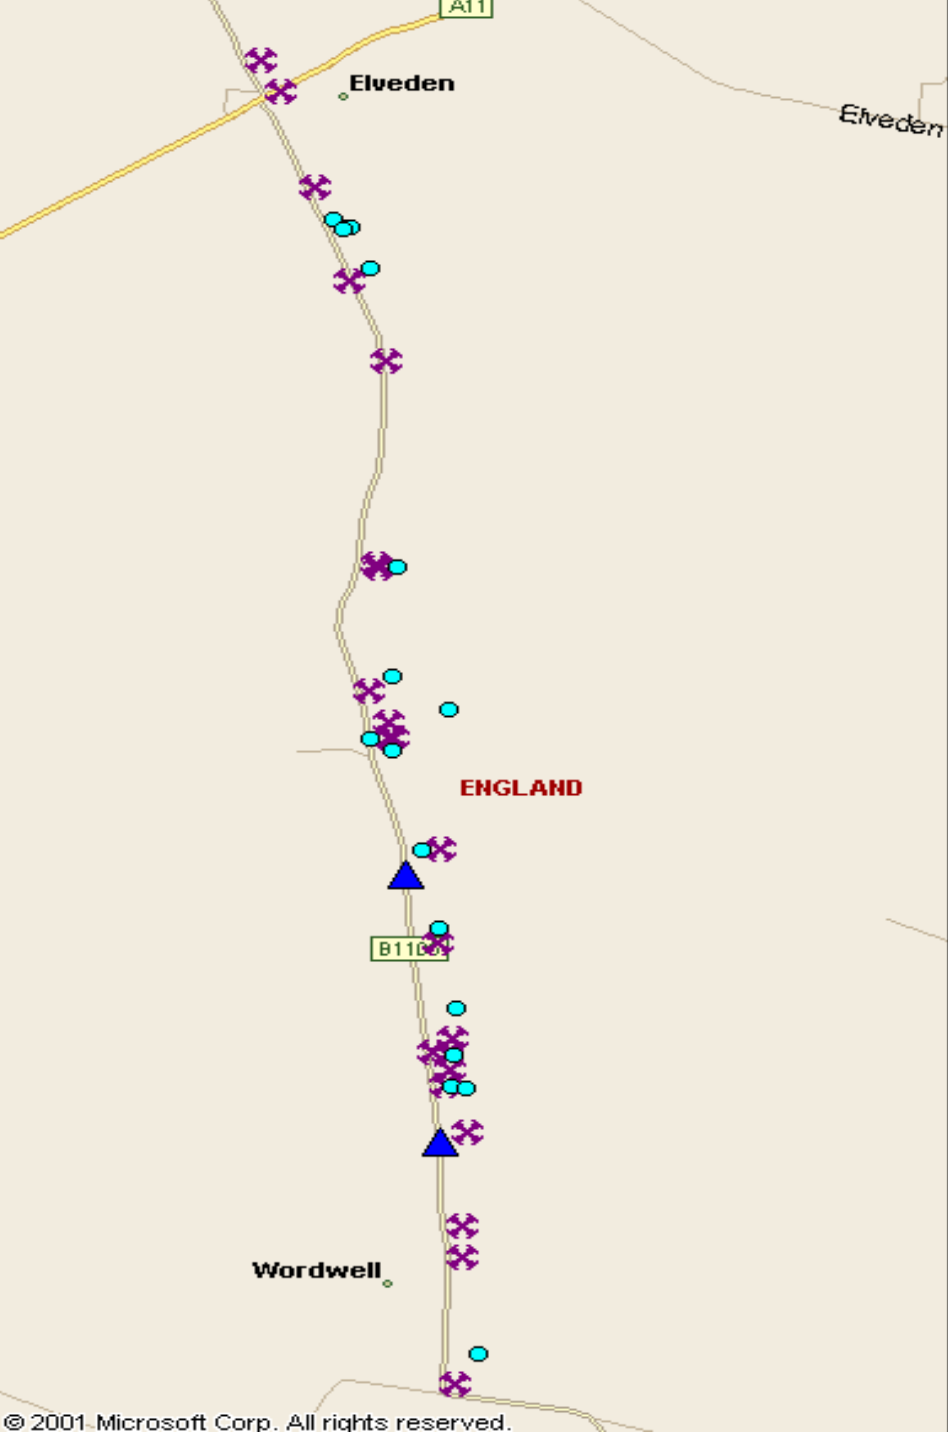
Purple Crosses = deer collisions
12mth prior to Rumble installation

Light blue dots = deer collisions
12mth period after Rumble
installation

Blue Triangles = Start and End of
Trial Section/Signage
